submitted to Composites Science and Technology
March 1997

AN IMAGE ANALYSIS TECHNIQUE FOR EVALUATING INTERNAL DAMAGE IN GRAPHITE/POLYIMIDE FABRIC COMPOSITES

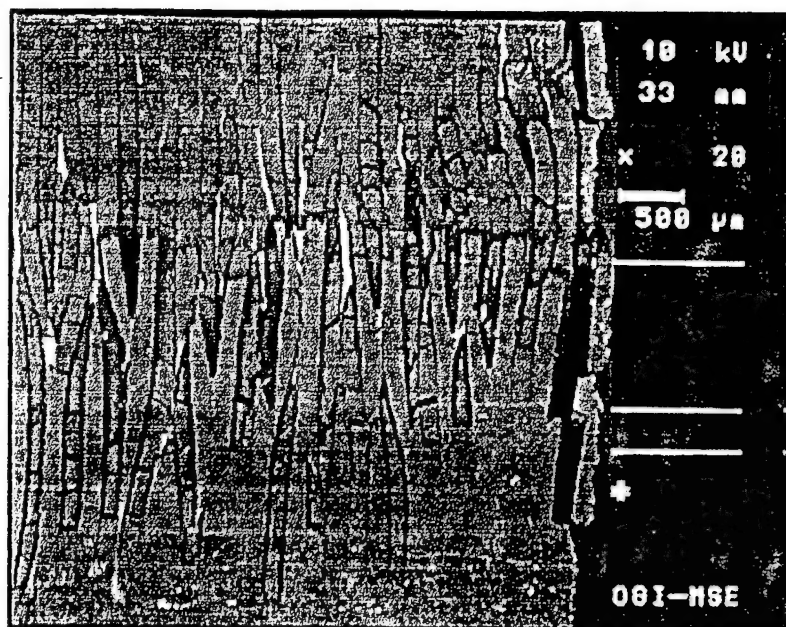
Figure 4

1. Large damage zones developed in the gage section of the specimens were observed. The zones consisted of multiple surface cracks (see Figure 4).

It was almost impossible to determine the mode of failure most prevalent i.e., intralaminar, interlaminar or translaminar.

4. Scanning electron microscope (SEM) micrograph of cracking within the notch root as viewed looking from the top
5. Scanning electron microscope (SEM) micrograph showing the out-of-plane deformation and internal cracking

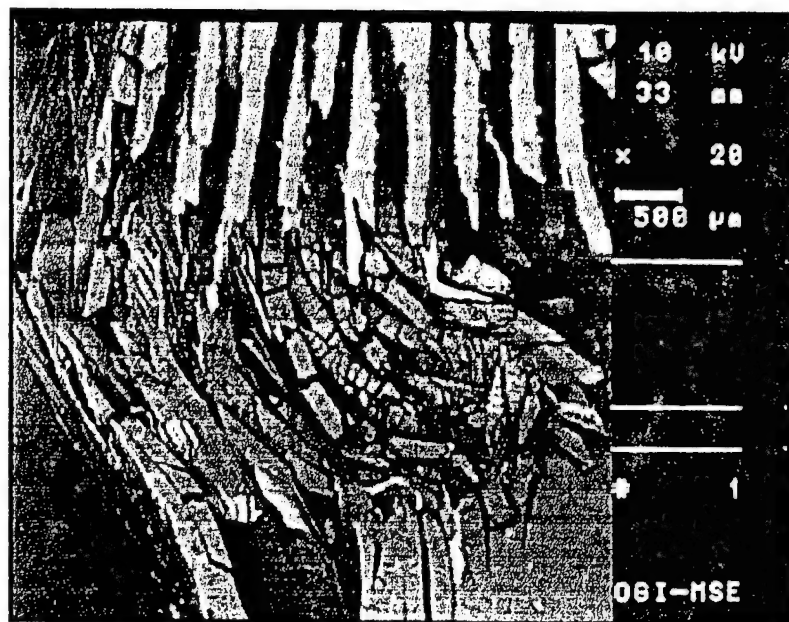
Figure 5

2. The damage zones were associated with significant and permanent out-of-plane deformations (bulging) on the surfaces of the specimens (see Figure 5). It seems that the specimen surface bulging developed just before the "damage trigger".
3. The damage zone morphology was almost identical for all loading angles. It appears, however, that damage zone size was slightly smaller in those samples tested in shear/compression in comparison to the zones developed under biaxial shear/tension loading conditions.

Simultaneously, the ends of the specimen move toward the center and kinking occurs. At some critical point during the loading process, interlaminar cracks develop and propagate, allowing the specimen to bulge outward from the centerline as shown in Figure 5. If the fracture toughness of the interfaces between the layers is low, some of the interlaminar cracks can propagate catastrophically along the specimen causing the load drops.

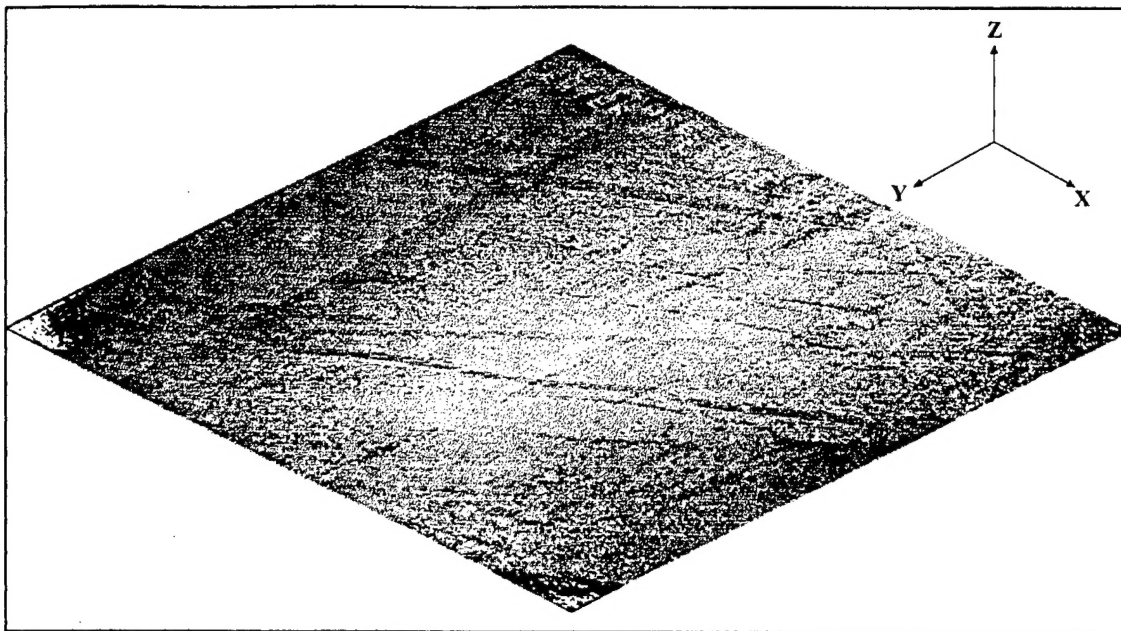
Figure 14a

Figures 14a and 14b show the projected three-dimensional reconstruction of the center and notch SEM targets from an assembly of index pairs 00-04. It can be seen from these figures that damage near the notch is not as pronounced and the majority of cracks follow diagonals similar to patterns where the warp/fill undulations are located. The projections give the illusion of transparency, but they actually represent a compilation of depth and intensity maps derived from the two-dimensional crack-laden stack averages. The darker corner areas are portions of the holes used to align each image from surface to sub-surface in sequence.
